Road Safety Audit Stage 3

A458 / Ridout Rd Cross Houses Shrewsbury

27/05/2022

Project Name:	A458 / Ridout Rd Cross Houses Shrewsbury
Project Number:	SRSS-019
Report Title:	Road Safety Audit Stage 3
Report Number:	Report SCC/2022/002

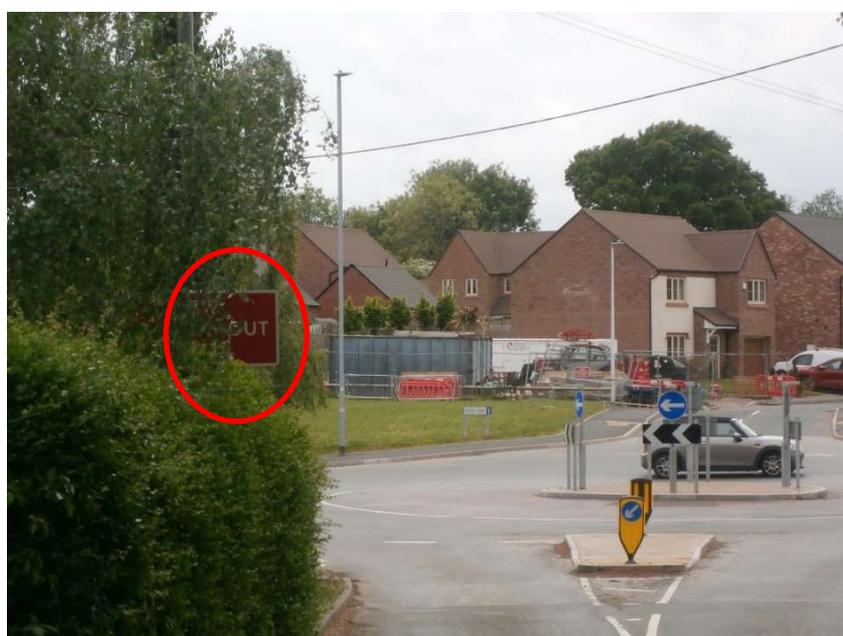
Location: Approach to new roundabout from unclassified Atcham Road.

Summary: Risk of failure to give way and loss of control incidents.

Although there is a temporary sign (Diag 7014) to warn motorists of the new roundabout ahead. It is located too close to the give way line to be effective. In addition to this the sign is obscured by vegetation and cannot be readily seen.

The lack of warning in advance of the junction may cause the motorist to excessive breaking or failure to give way. This may result in side impact collisions with vehicles already on the circulatory carriageway or nose to tail collisions arising from sudden breaking

Photograph 1: Warning of new roundabout on unclassified road from Atcham, too close to junction and obscured by vegetation

This sign should be repositioned and made clearly visible for approaching vehicles

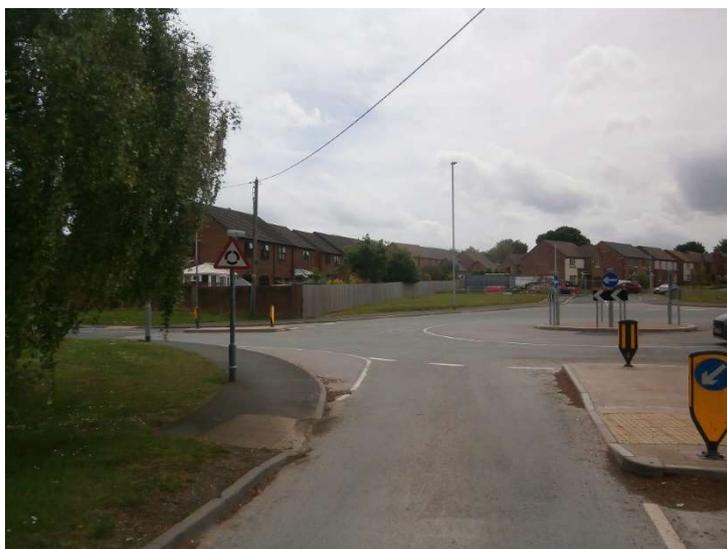
Location: Unclassified road from Atcham at giveaway on roundabout.

Summary: Inappropriate sign may cause confusion and driver hesitancy

The original existing sign post for the mini roundabout sign has been re-used to mount a roundabout warning sign (TSRGD Diag 510). This sign should be in advance of the junction to warn motorists of a junction ahead. By placing this sign at the give way line is inappropriate and may cause driver confusion or hesitancy resulting in sudden breaking and nose to tail collisions

Photographs 2: inappropriate position of warning sign of roundabout ahead sign

That the sign should be relocated to a more suitable location in advance of the roundabout. Due to the nature and alignment of the road it may also be beneficial to have a supplementary distance plate mounted below the warning sign denoting the distance to hazard

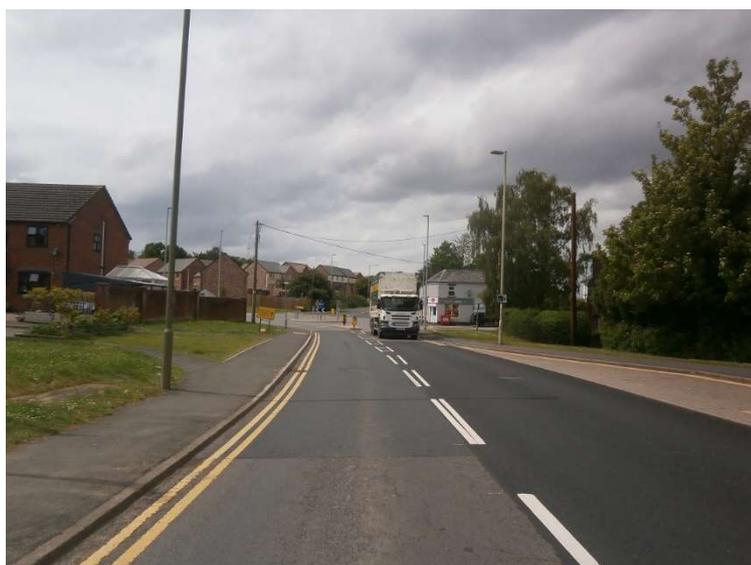
Location: A458 Westbound approach to island (Towards Shrewsbury).

Summary: Risk failure to give way

There is no deflection on the approach to the roundabout for vehicles travelling west towards Shrewsbury. The overrun area to accommodate the turning manoeuvres of HGVs around the roundabout, also allows motorists to take the 'racing line' through the junction. (See also Problem 3.4)

This could result in failure to give way and side impact collisions with vehicles already on the circulatory carriageway heading into the new development

Photograph 3: Lack of deflection on approach (Westbound) to roundabout towards Shrewsbury

Provide appropriate speed reducing measures such as 'SLOW' road markings for northbound vehicles prior to negotiating the junction. (See also problem 3.4)

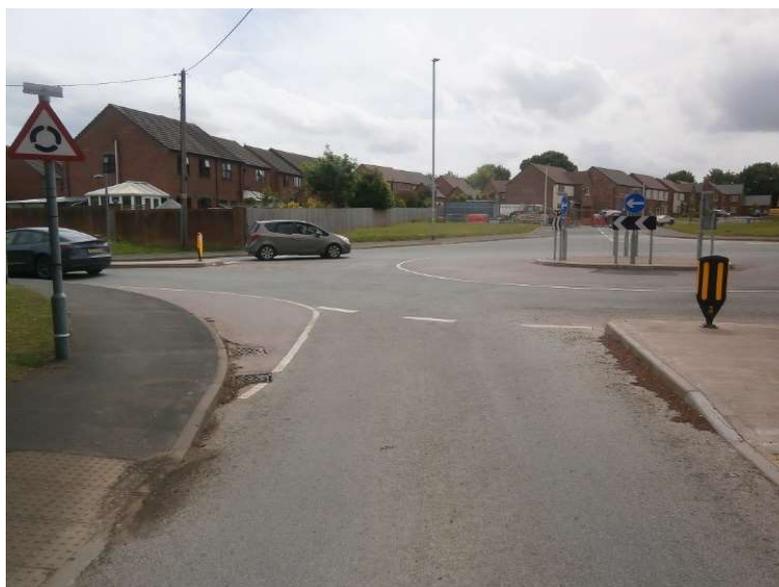
Location: A458 Eastbound approach to roundabout (Towards Cressage).

Summary: Risk failure to give way.

There is no deflection on the approach to the roundabout for vehicles travelling west towards Shrewsbury. The overrun area to accommodate the turning manoeuvres of HGVs around the roundabout, also allows motorists to take the 'racing line' through the junction. (See also Problem 3.4)

This could result in failure to give way and side impact collisions with vehicles already on the circulatory carriageway heading into the new development

Photograph 4: Lack of deflection prior to roundabout

Provide appropriate speed reducing measures such as 'SLOW' road markings for northbound vehicles prior to negotiating the junction. (See also problem 3.3)

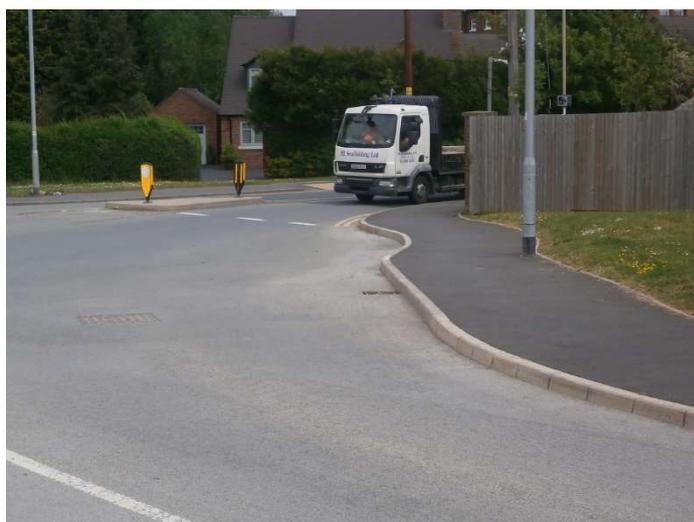
Location: Circulatory carriageway between A458 and Ridout Road.

Summary: Risk of loss of control collisions.

The kerb alignment and over run area for the roundabout has resulted in a large expanse of carriageway which is continuously unused. This has led to a build up of detritus material lying within the circulatory carriageway. This may cause some vehicles to lose control, particularly powered two wheeled vehicles who may momentarily lose control with the rider becoming unseated. This could result in injury to vulnerable road users

Photograph 5: Build up of detritus material on circulatory carriageway

The road surface around this junction should be subject to routine maintenance regime of being regularly swept to keep the circulatory carriageway free from a build-up of detritus material.

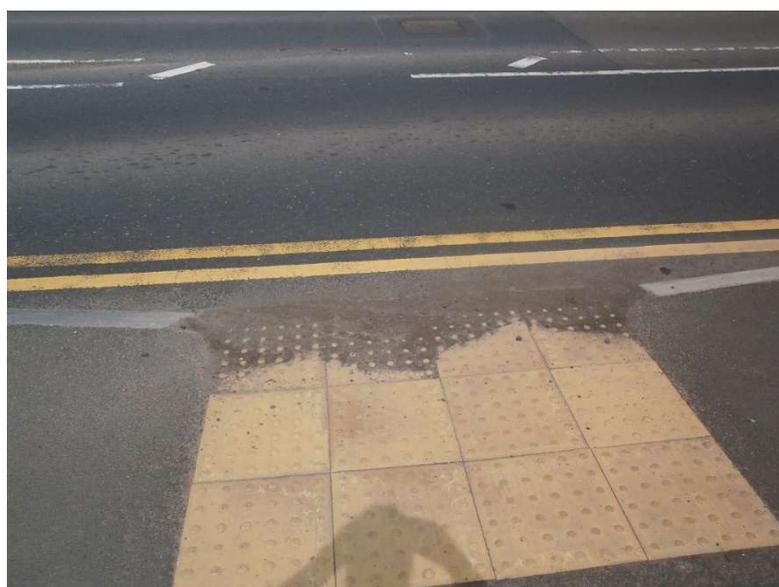
Location: Pedestrian crossing point to east of roundabout on A458.

Summary: Risk of slip trip and fall collisions.

The pedestrian crossing point on the A458 to the east of the roundabout has a build up of detritus material indicating that the carriageway is not draining correctly. The build-up of detritus material may result in a build up of water which may freeze in the winter months. This could lead to slip trip and fall incidents.

Photograph 5: Build-up of detritus material at crossing point on A458 east of roundabout

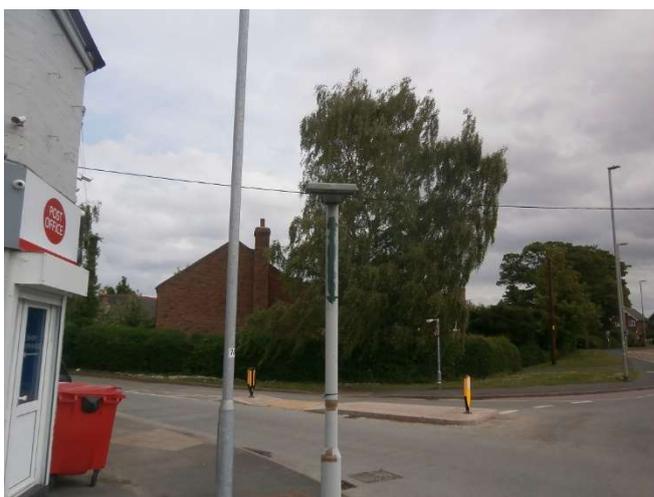
Location: A458 eastbound approach to roundabout (Towards Cressage)

Summary: Redundant road sign post from previous mini roundabout sign

The previous post and illumination unit for the mini roundabout sign on the approach to the roundabout is still insitu although the sign has been removed. This should be removed.

Photograph 6: Redundant signpost at give way to roundabout (Eastbound towards Cressage)

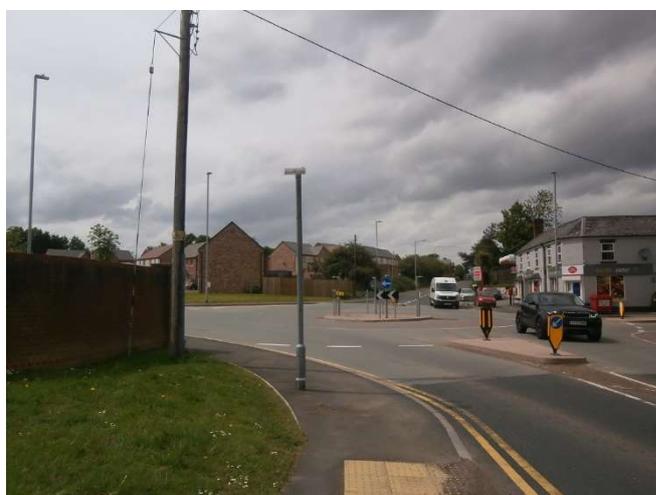
Summary: Redundant road sign post from previous mini roundabout sign

The previous post and illumination unit for the mini roundabout sign on the approach to the roundabout is still insitu although the sign has been removed. This should be removed.

Photograph 7: Redundant signpost at give way to roundabout (Westbound towards Shrewsbury)
