Road Safety Audit Stage 3

A458 / Ridout Rd Cross Houses Shrewsbury

27/05/2022

Project Name:	A458 / Ridout Rd Cross Houses Shrewsbury
Project Number:	SRSS-019
Report Title:	Road Safety Audit Stage 3
Report Number:	Report SCC/2022/002

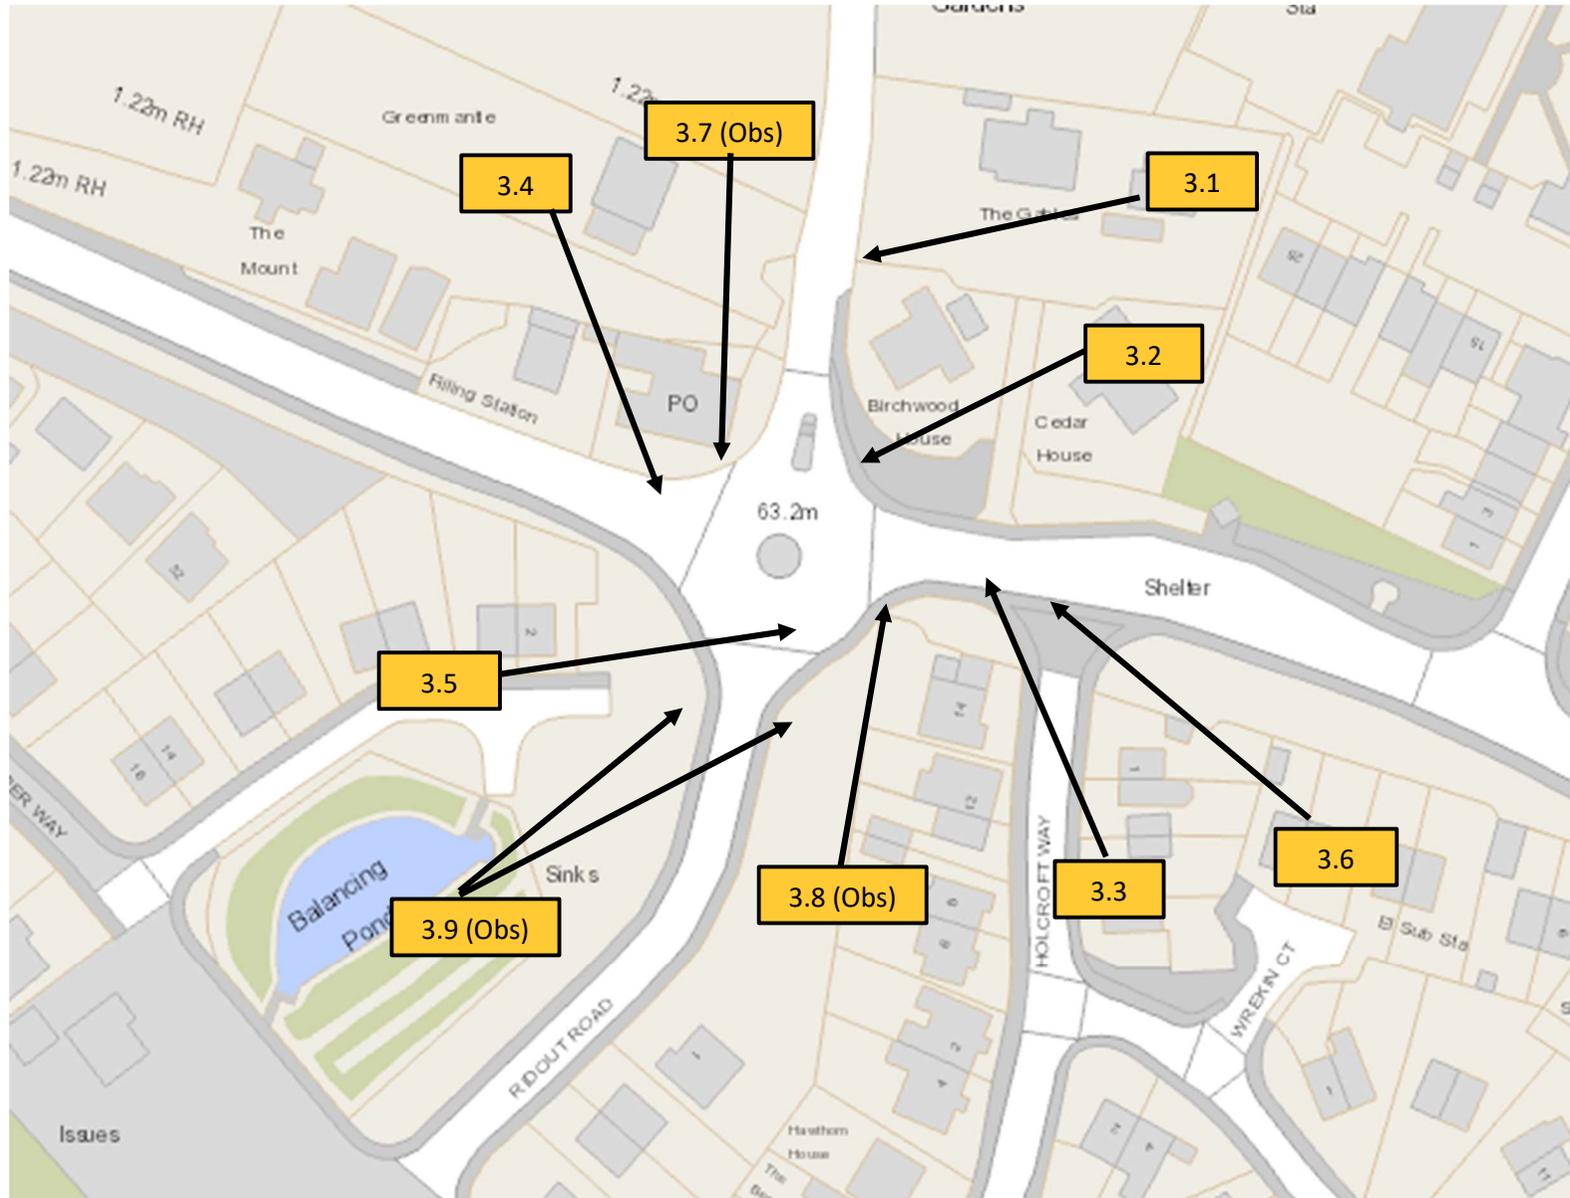
Appendix D: Problem Location Plan

Please refer to the following page for a plan illustrating the locations of the problems identified as part of this audit (location numbers refer to paragraph numbers in the report).
